From: Christopher Byrum <chris.byrum1037@yahoo.com>
Sent: Tuesday, November 9, 2021 9:17 AM
To: Berkholz, Aaron; Murphy, Nate
Subject: C. Byrum summary memo - Grove Rd second opinion
Attachments: Grove Rd Creep - Byrum Sketches.pdf

Hello Aaron and Nate – This email summarizes my data analysis and evaluation of the creeping river bank slope and sheet pile wall on Grove Road near Ypsilanti, Michigan. In general, I understand the creeping slope had damaged the previous edge of roadway and storm outlet utilities in this area. A design team was hired a few years ago to develop a solution to the problem. a large steel sheet pile wall was installed on the river side of the roadway in the creep area in attempt to stop the ongoing creep movements of the roadway and sidewalk. I understand creep deformations have continued and the top of the new sheet pile wall has now moved outward by about 3-4 inches and slope slough creep is continuing to occur. The active wedge of soil retained by the wall has shifted and is starting to extend into the recently repaired roadway, causing settlements and cracking of the paved lane and curb line. A newer watermain exists under the sidewalk that is settling

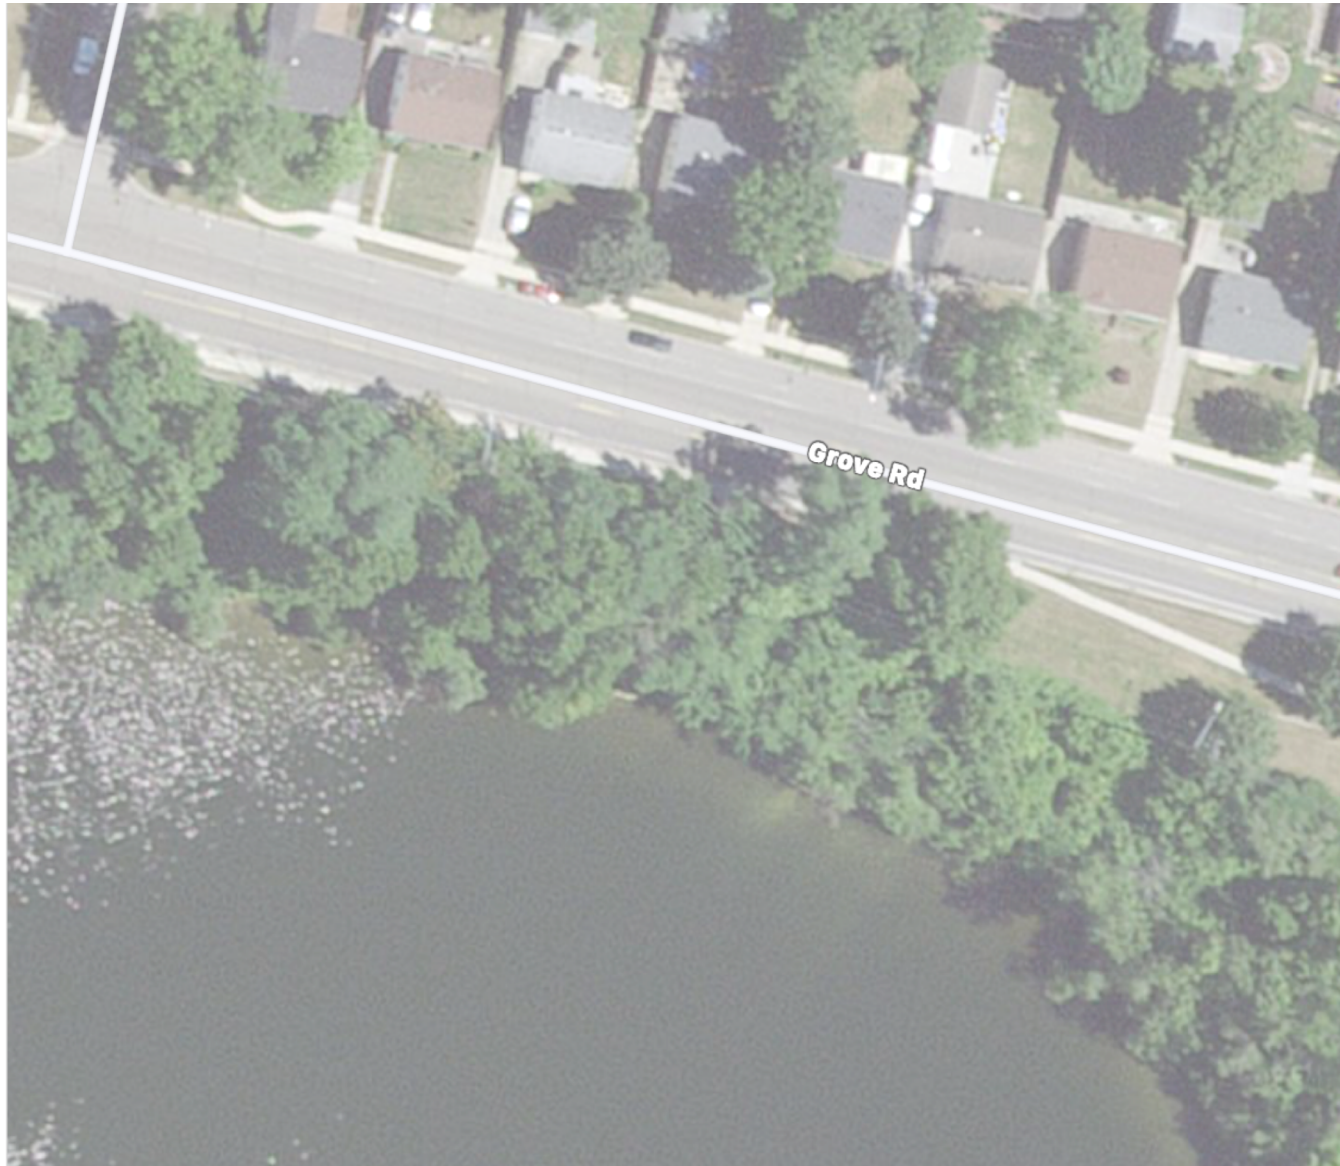
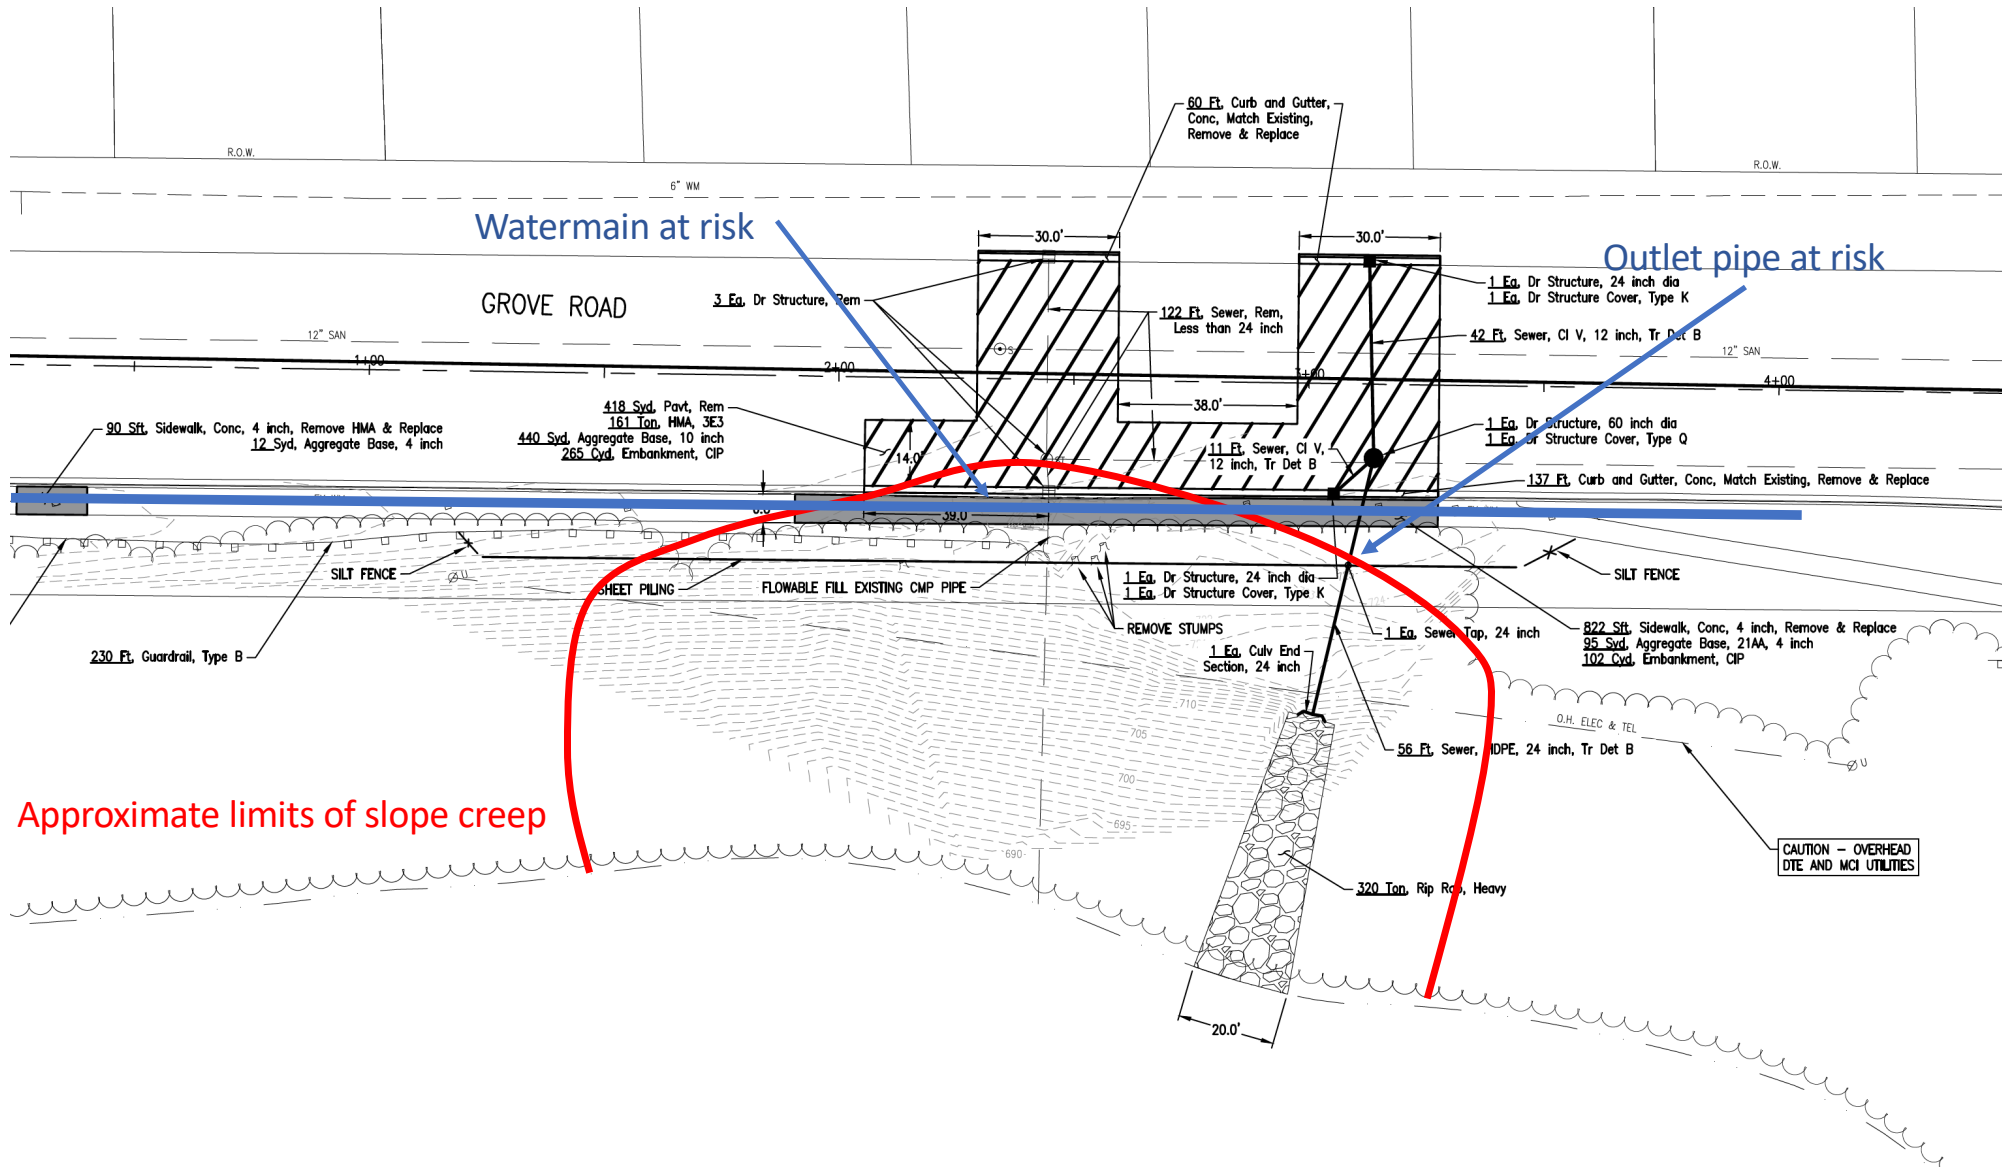
I have attached a pdf file containing my generalized interpretation of the limits and nature of the slope creep zone. Some recommendations we discussed are as follows:

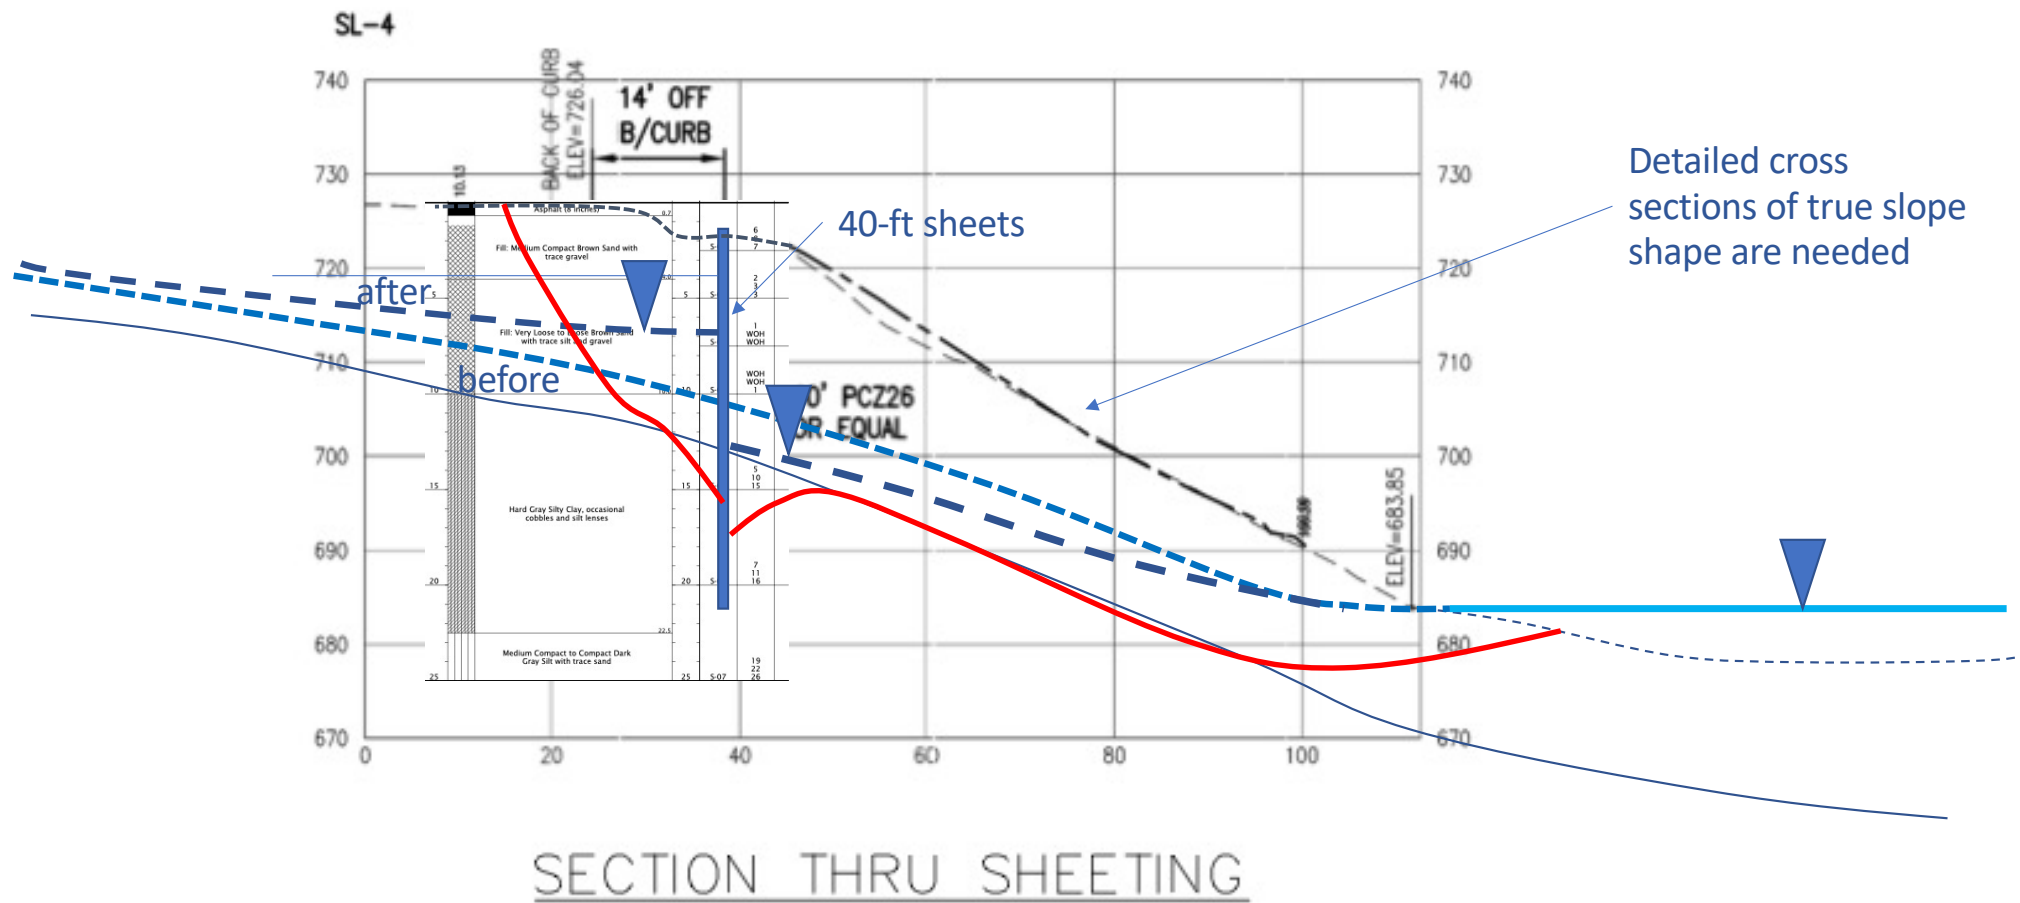
Approximate nature of the slip zone near center of mass
