# ROAD SAFETY AUDIT PRELIMINARY FINDINGS MEETING

Rawsonville Road from  
Martz Road to .38 miles North of Textile Road

June 1, 2026

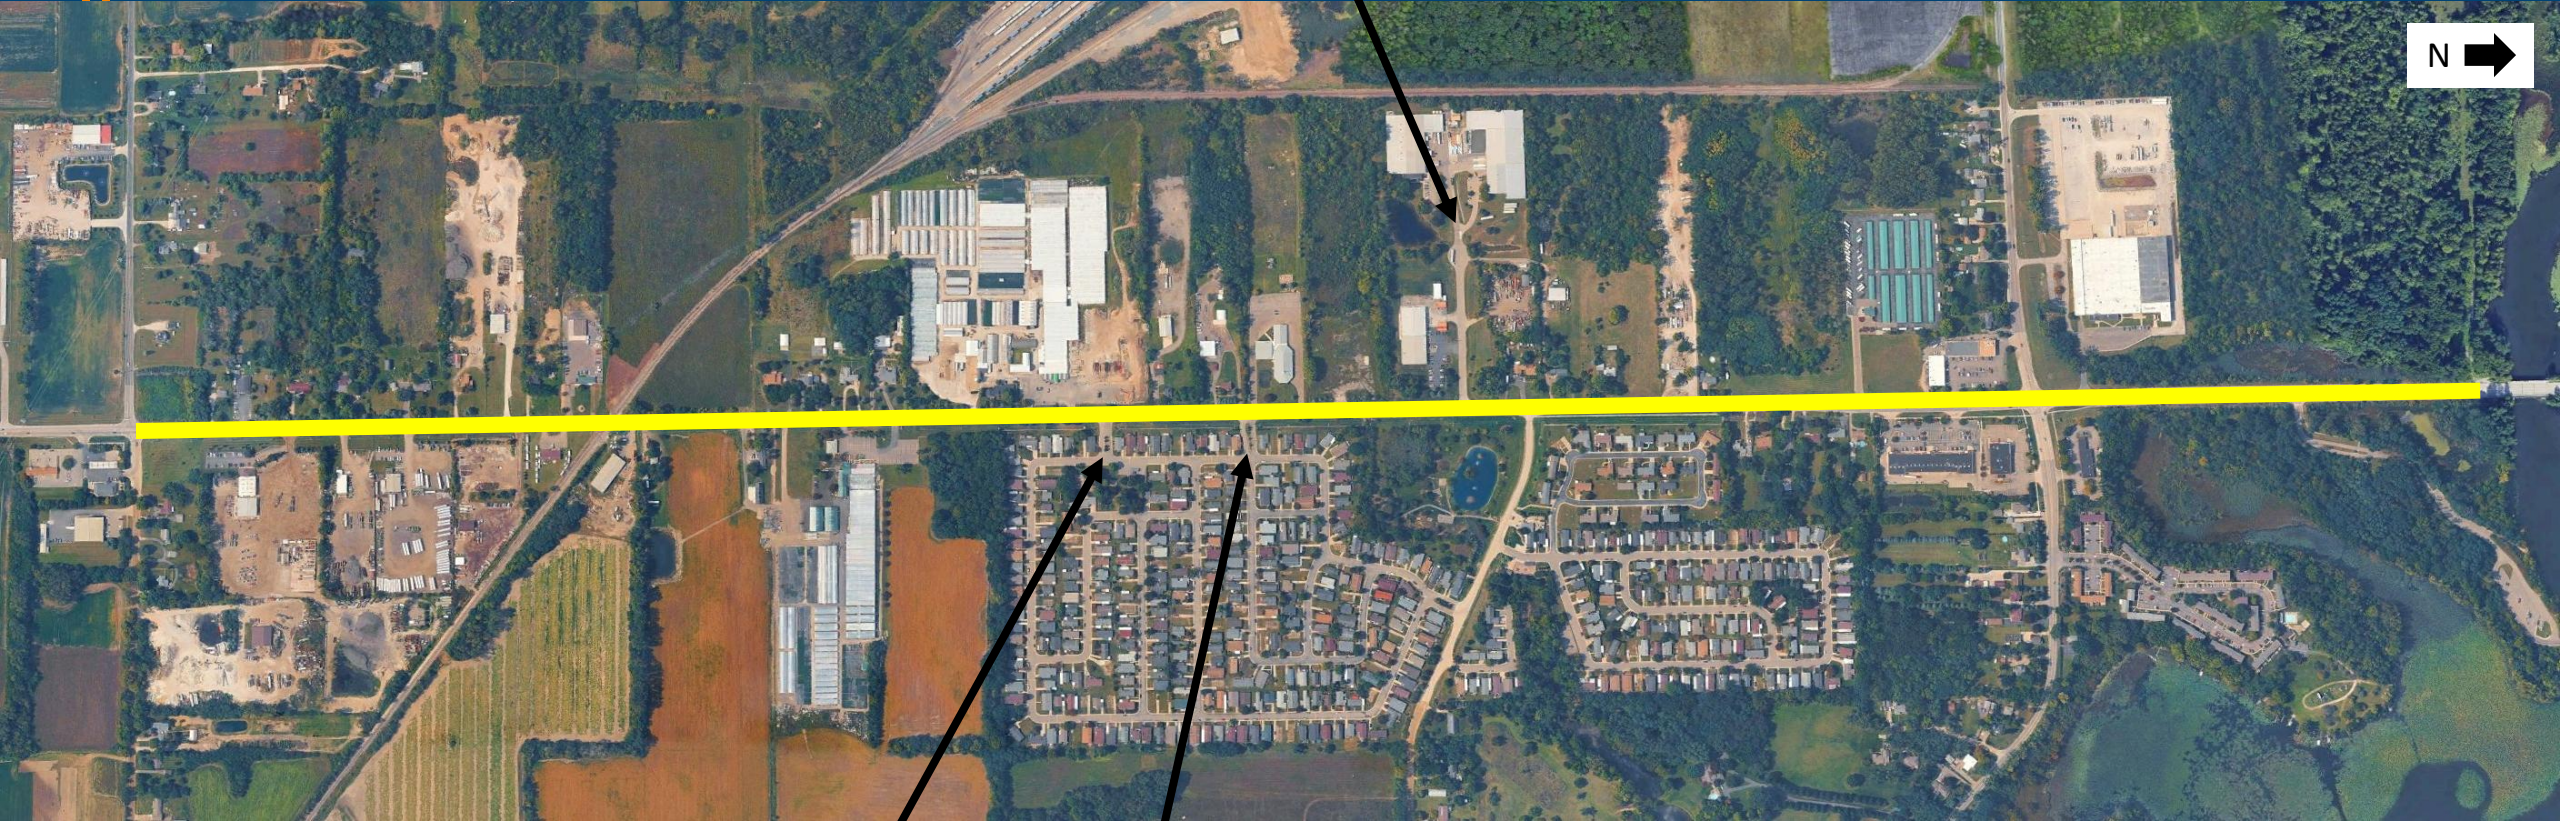
# Study Limits of Rawsonville Road

Martz Road

Blackmore Ave

Textile Rd

Capitol Dr

Presidential Dr

Bog Rd

Huron River Dr

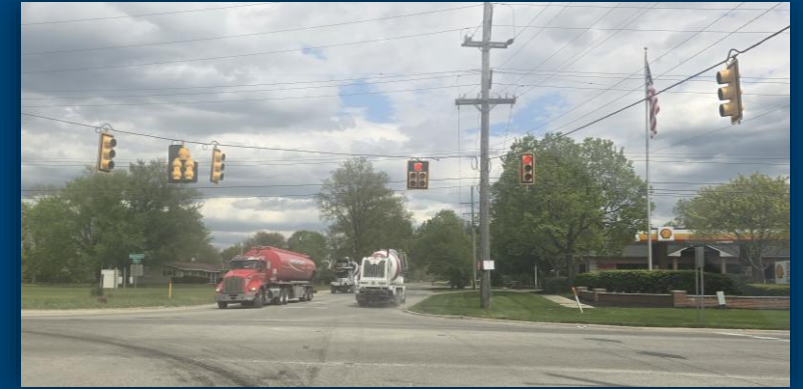
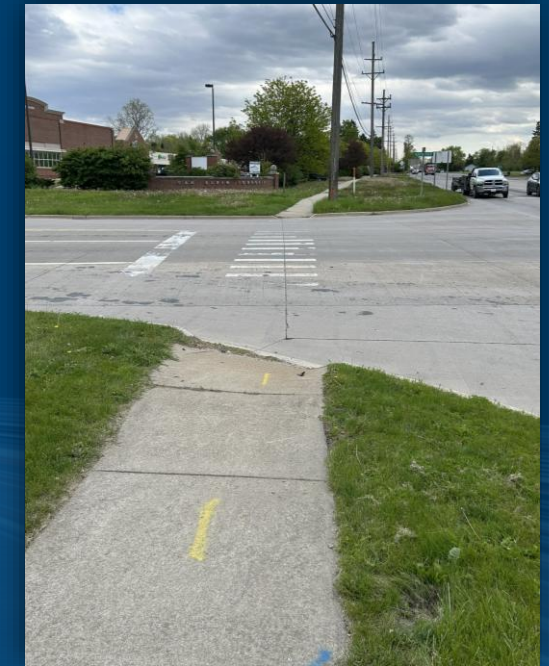
# Positive Observations

- Lighting present at railroad crossings, private roads, some business driveways
- Signal backplates and partial box span at Martz Rd
- Lane use control signs at signalized intersections
- Some sidewalk, crosswalk markings, and sidewalk connections

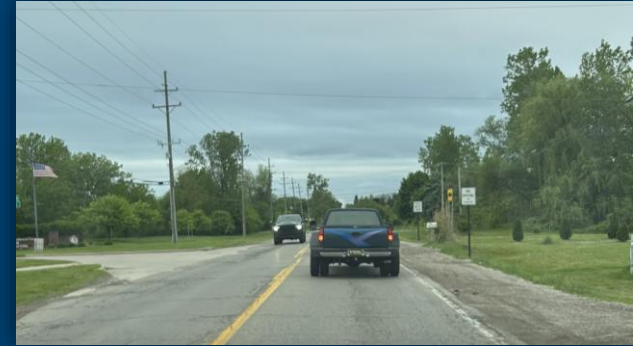
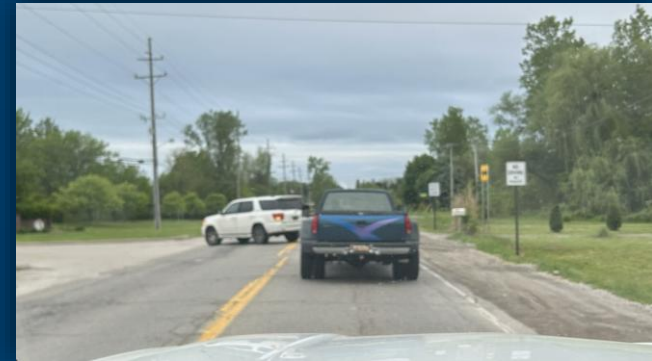
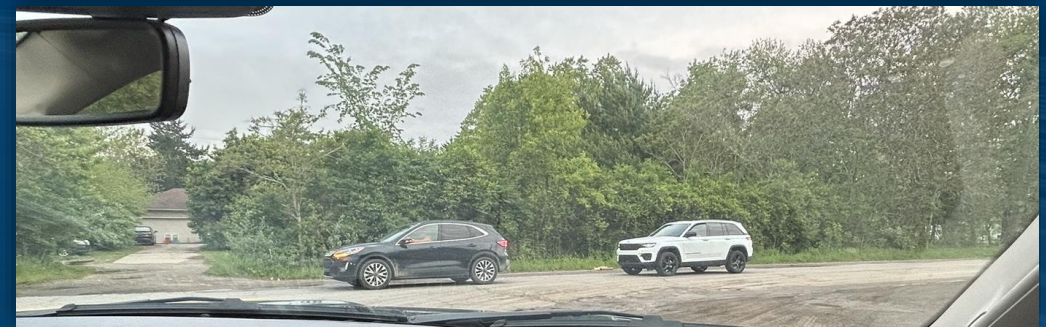
# Rawsonville Rd Corridor

- Issue: Vehicles turning left from Rawsonville Rd impede traffic while waiting for gaps
  - This prompts driver to undertake illegal/dangerous passing maneuvers on shoulders or across solid yellow lines to pass turning vehicles
  - Leads to unexpected stops on a high-speed roadway
  - High concentration of driveways

At least 11 crashes (1 Serious Injury) related to left turns on two lane section of Rawsonville Rd

- Recommendation: Add center two-way left-turn lane to Rawsonville Rd
  - Dedicated space for vehicles to wait for traffic to clear before making turn
  - Removes turning vehicles from travel lane, reducing congestion

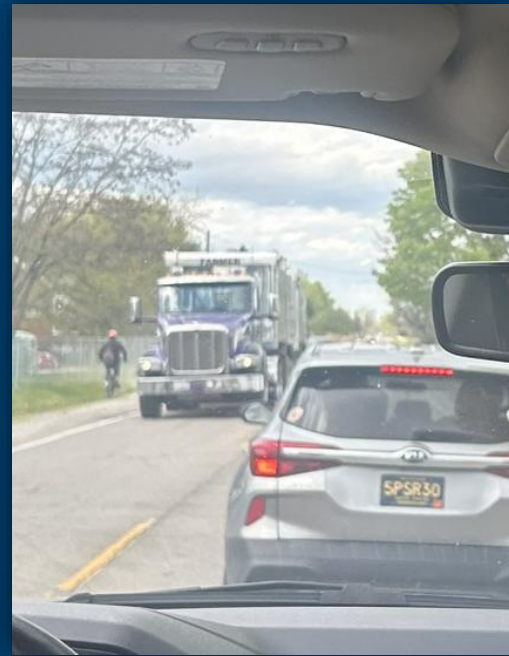
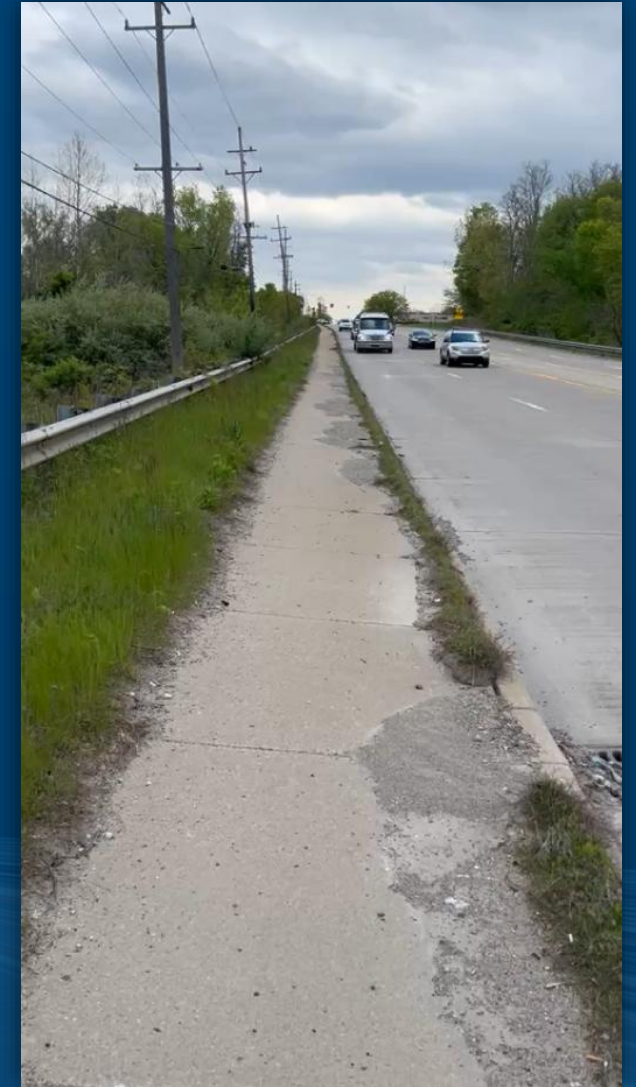
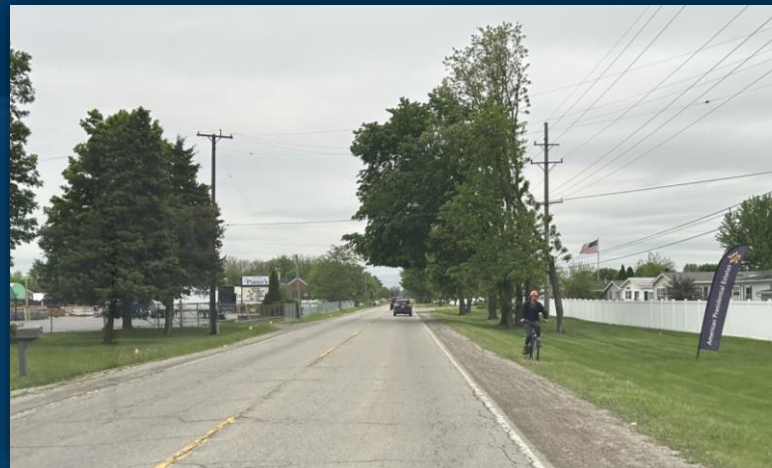
# Non-Motorized

- Issue north of Textile Rd: Sidewalk is not comfortable for non-motorized users
- Issue south of Textile Rd: lack of non-motorized facilities
  - Pedestrians and bicyclists are forced to walk and bike on the road, on the shoulder, or in the grass

- Recommendation north of Textile Rd:  
Add buffer between vehicular traffic and sidewalk
- Recommendation south of Textile Rd:  
Add a 10' shared use path on the east side of Rawsonville Rd
  - Enhances accessibility

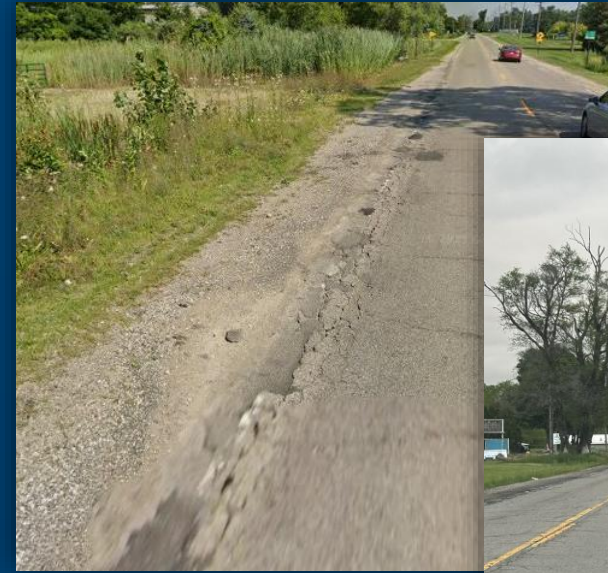
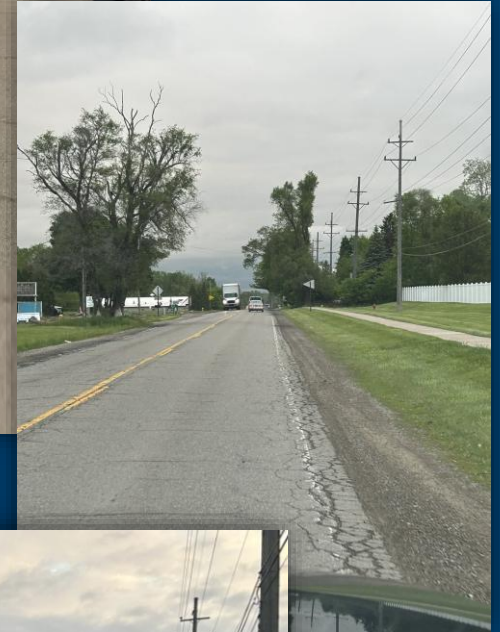
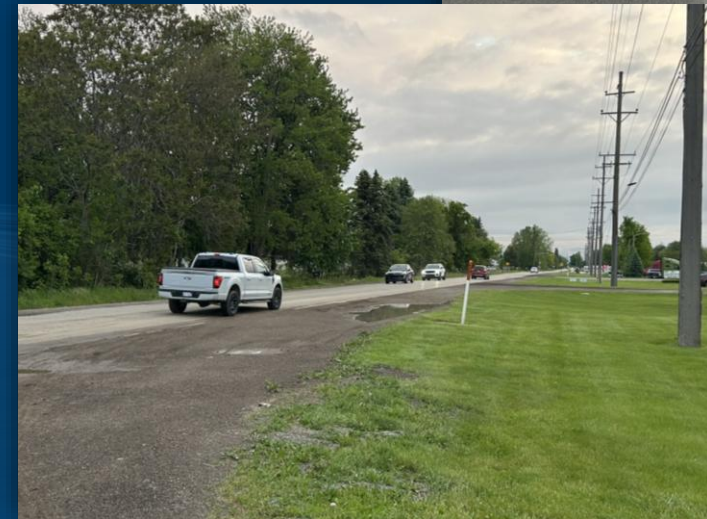
# Pavement Condition

- Issue: Pavement Condition
  - PASER Rating 2 (POOR) on most of study area
  - Deteriorated shoulders and edge pavement failure observed
  - Water pooling and drainage issues
  - Instances of swerving to avoid potholes
  - Poor pavement marking adherence to road surface, leading to reduced visibility

- Medium Term Recommendation: Reconstruct road with paved shoulders
- Short Term Recommendation: Spot repairs, gravel shoulder upgrades, refresh pavement markings

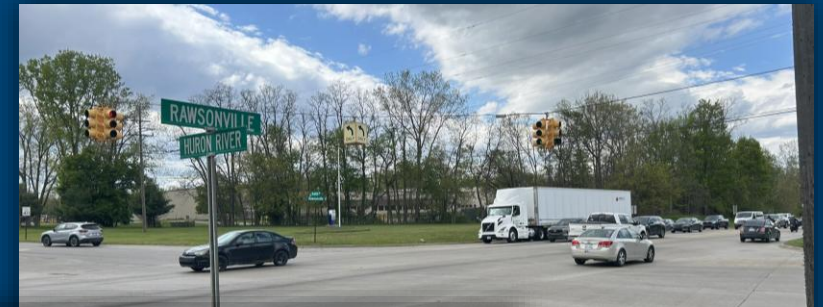
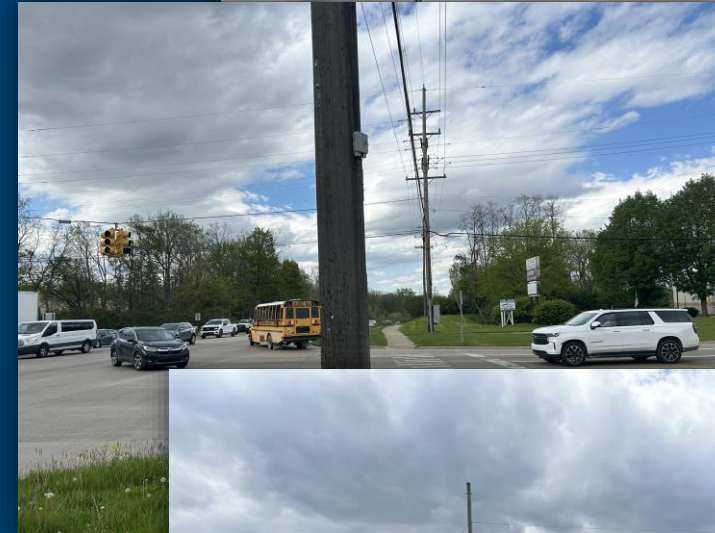
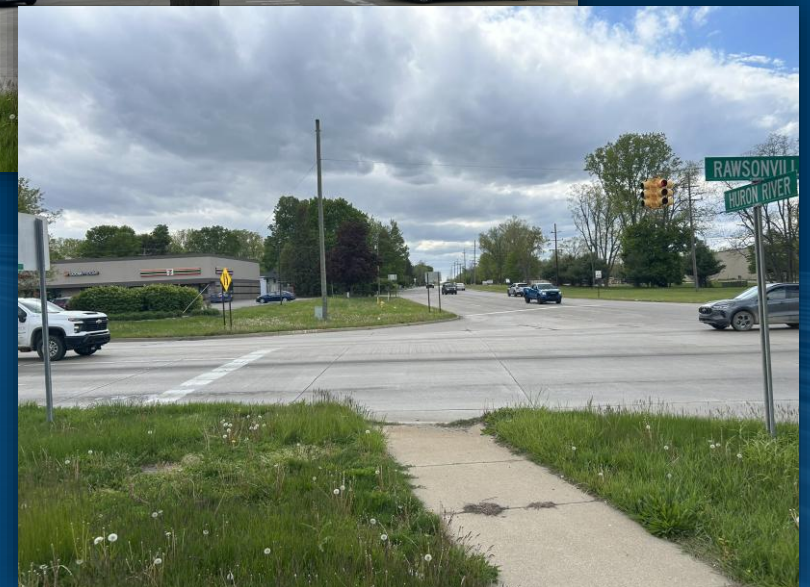
# Rawsonville Rd at Textile Rd

- Issue: Outdated signal, lack of non-motorized facilities

- Red light running

At least 11 crashes (1 Fatality) related to red light running from 2021-2025

- Lack of left turn phasing

At least 18 crashes (1 Serious Injury) related to left turns failing to yield from 2021-2025

- Recommendation: Modernize
  - Box span design
  - Signal backplates
  - Left turn FYA signal heads with detection and dedicated phase
  - Intersection lighting
  - Dilemma zone detection
  - ADA compliant sidewalk, sidewalk connections, and continental crosswalk pavement markings
  - Pedestrian countdown signal heads and pushbuttons

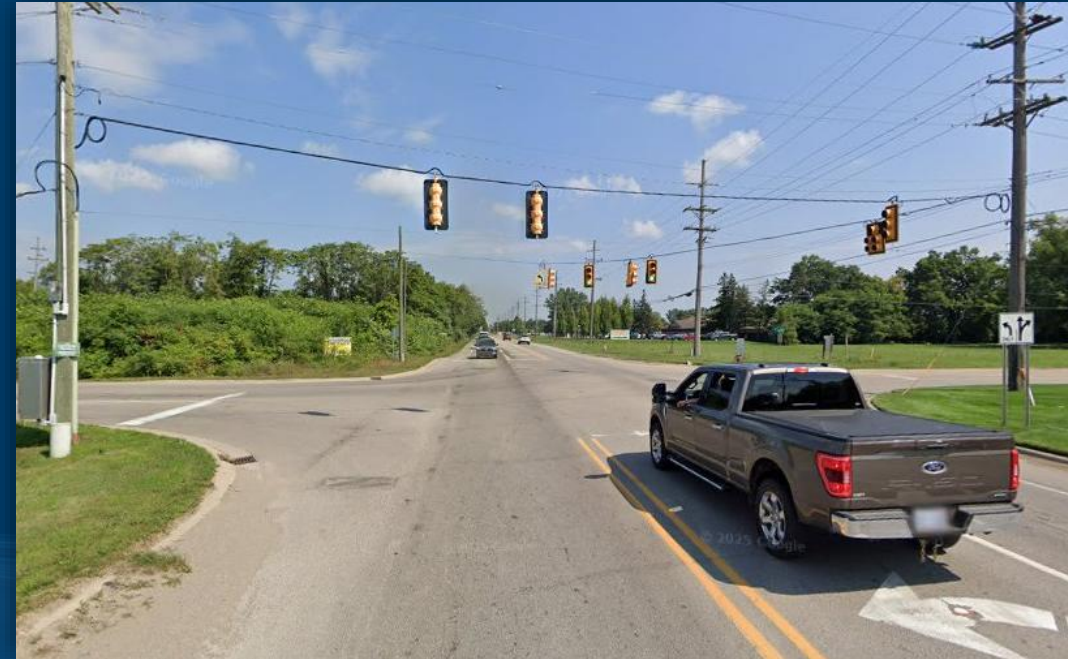
# Rawsonville Rd at Martz Rd

- Issue: Outdated signal, lack of non-motorized facilities

22 rear end crashes (1 Serious Injury) from 2021-2025

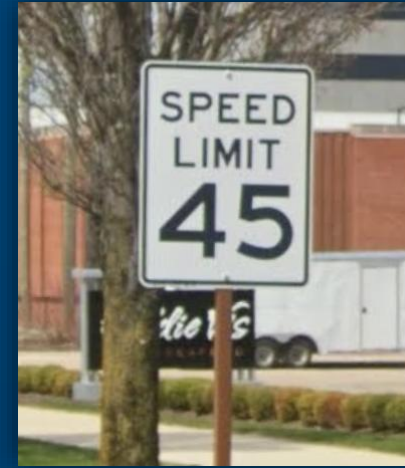
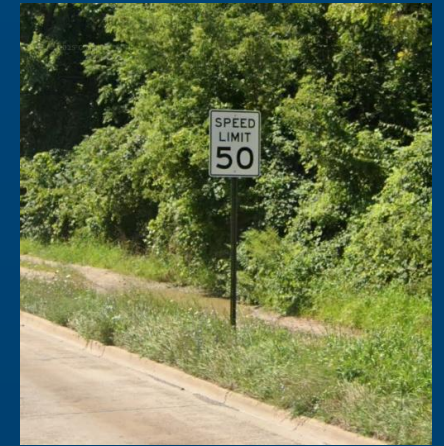
# Speed (cont.)

- Issue: Inconsistent speed limits
  - From I-94 to Willis Rd (~4mi), the speed limit changes 3 times

- Recommendation: Design corridor for consistent speed limits
  - Explore designing potential three-lane section for a 45 MPH speed limit
  - Ensure speed limits match the context of the road

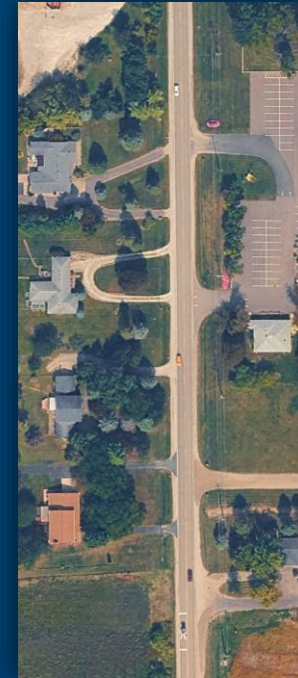
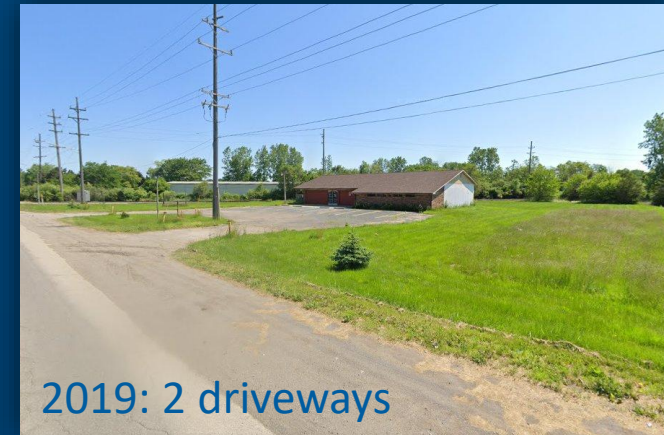
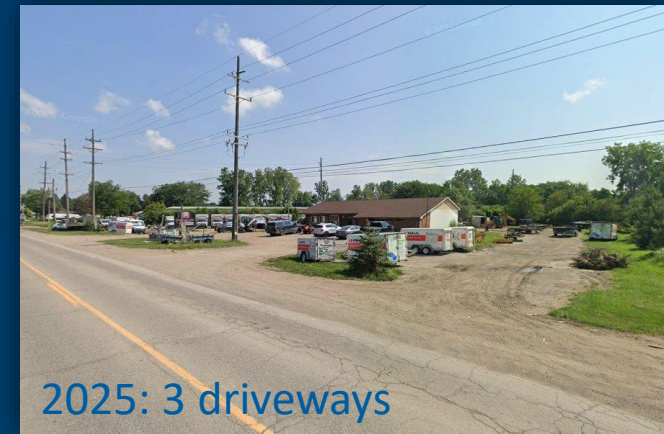
# Access Management

- Issue: Number of driveways
  - Driveway Count:
    - Martz Rd to Railroad: 17
    - Railroad to Bog Rd: 26
    - Bog Rd to Textile Rd: 20
    - Textile Rd to 0.38mi North of Textile Rd: 2
- The whole corridor (~1.9mi) has 34 driveways/mi
  - Martz Rd to Textile Rd (~1.5mi), has 42 driveways/mi
- Some homes and businesses have multiple driveways
- Land for sale in the area will lead to more driveways on this corridor

- Short Term Recommendation: Ensure best access management practices are being followed during the site plan review process
- Medium Term Recommendation: Pave driveway aprons

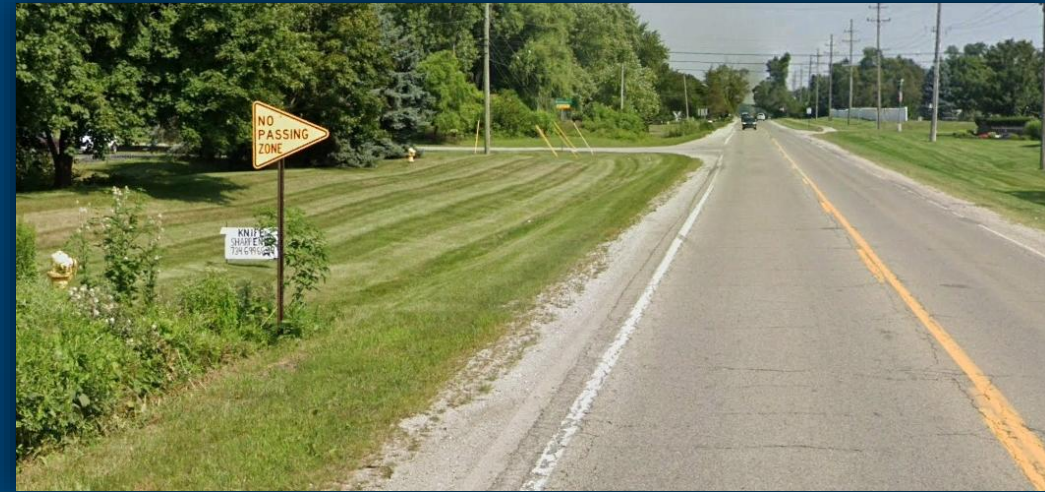
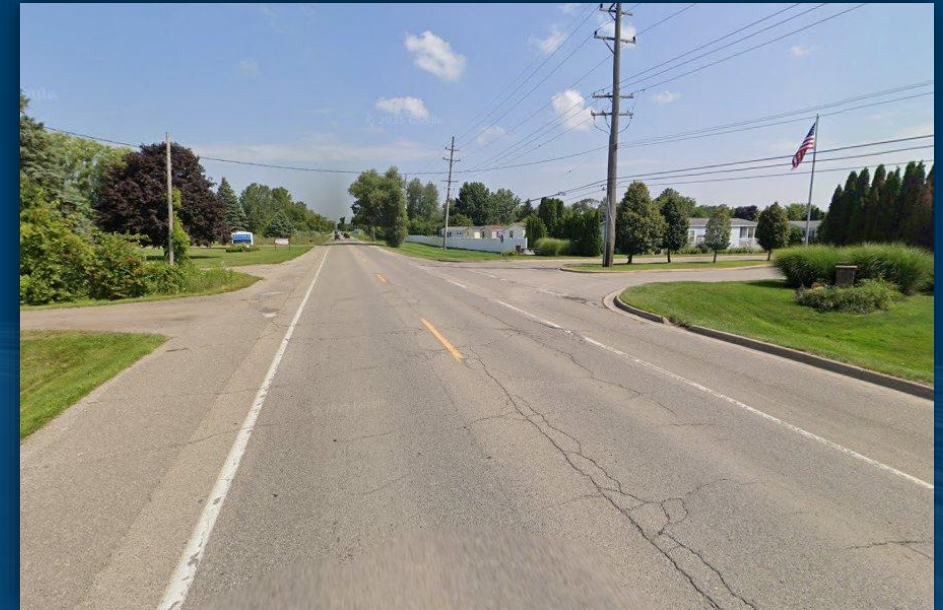
# Passing Zones

- Issue: Passing is allowed on some stretches of the corridor
  - High number of driveways and turning movements
  - Dangerous passing maneuvers observed more than once
  - Passing is allowed through some unsignalized intersections

At least 12 crashes (2 Serious Injuries) related to passing from 2021-2025

- Short Term Recommendation: Remove passing zones and associated signage from Textile Rd to Martz Rd
- Medium Term Recommendation: Install centerline rumble strips and edgeline rumble strips
- Long Term Recommendation: Install center two-way left-turn lane

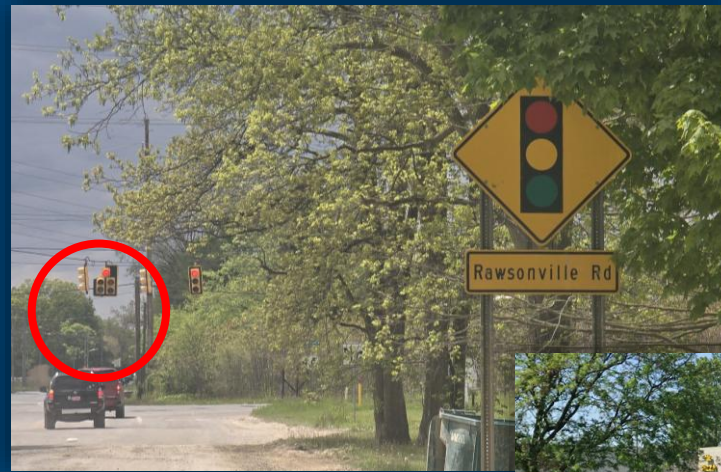
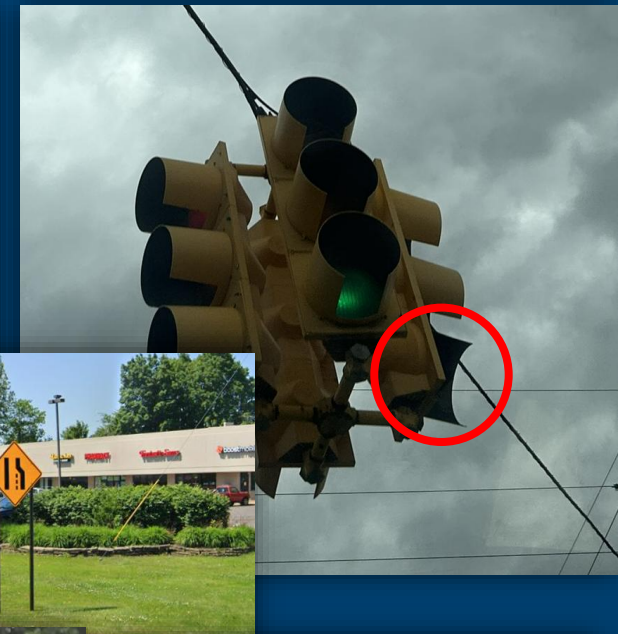
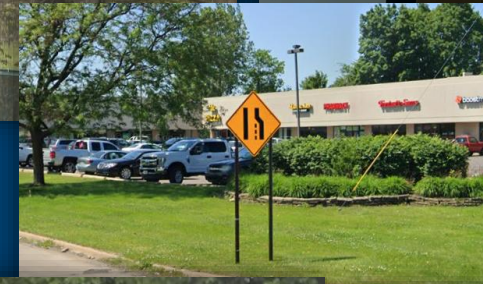
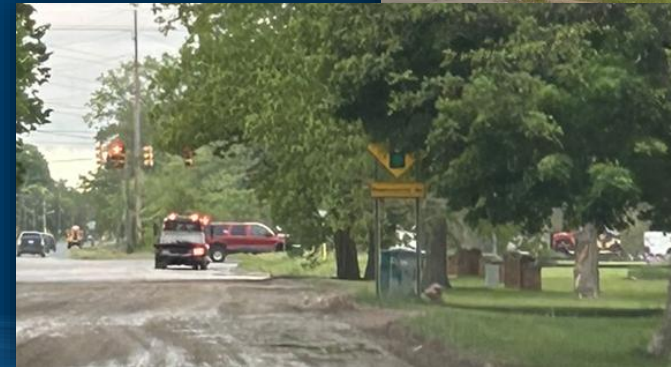
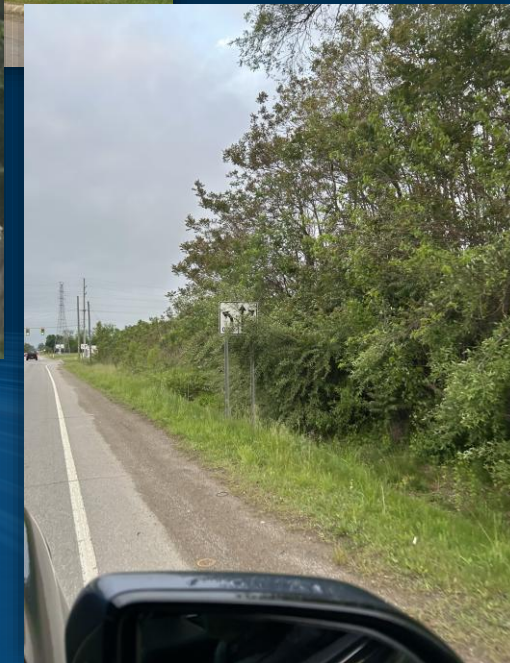
# Signing/Visibility

- Issue: Visibility
  - Cracked backplate, missing signal lens cap, obscured signs, low retroreflectivity
- Issue: Placement of signs and sign types
  - ENDS plaque on speed limit sign
  - Lane ends merge left sign should be 885' in advance of merge at 50 MPH. Only 425' currently

At least 3 crashes related to this merge from 2021-2025

- Recommendation: Ensure traffic control devices and signs are visible to road users
- Recommendation: Ensure compliance with MMUTCD and the best signs are used for the situation
  - Replace W3-3 signs with D3-2 signs
  - Remove speed limit ends plaque, put up speed limit 55 MPH signs
  - Add additional lane ends merge left warning sign and merge pavement markings

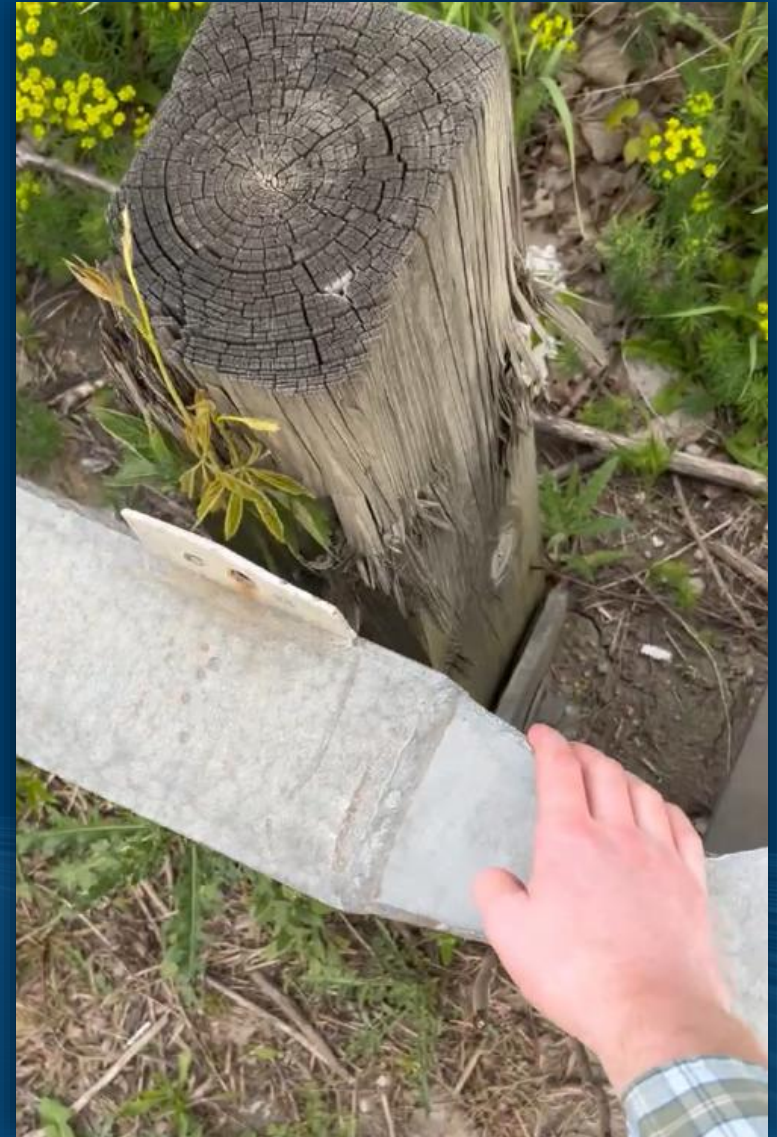
# Guardrail

- Issue: Guardrail is in need of maintenance
- Recommendation: Inspect and bring all guardrail up to compliance
