**STORMWATER SYSTEMS
ASSET MANAGEMENT PROGRAM**

**WASHTENAW COUNTY ROAD COMMISSION
(WCRC)**

EGLE SAW GRANT #1256-01

FINAL: DECEMBER 2020

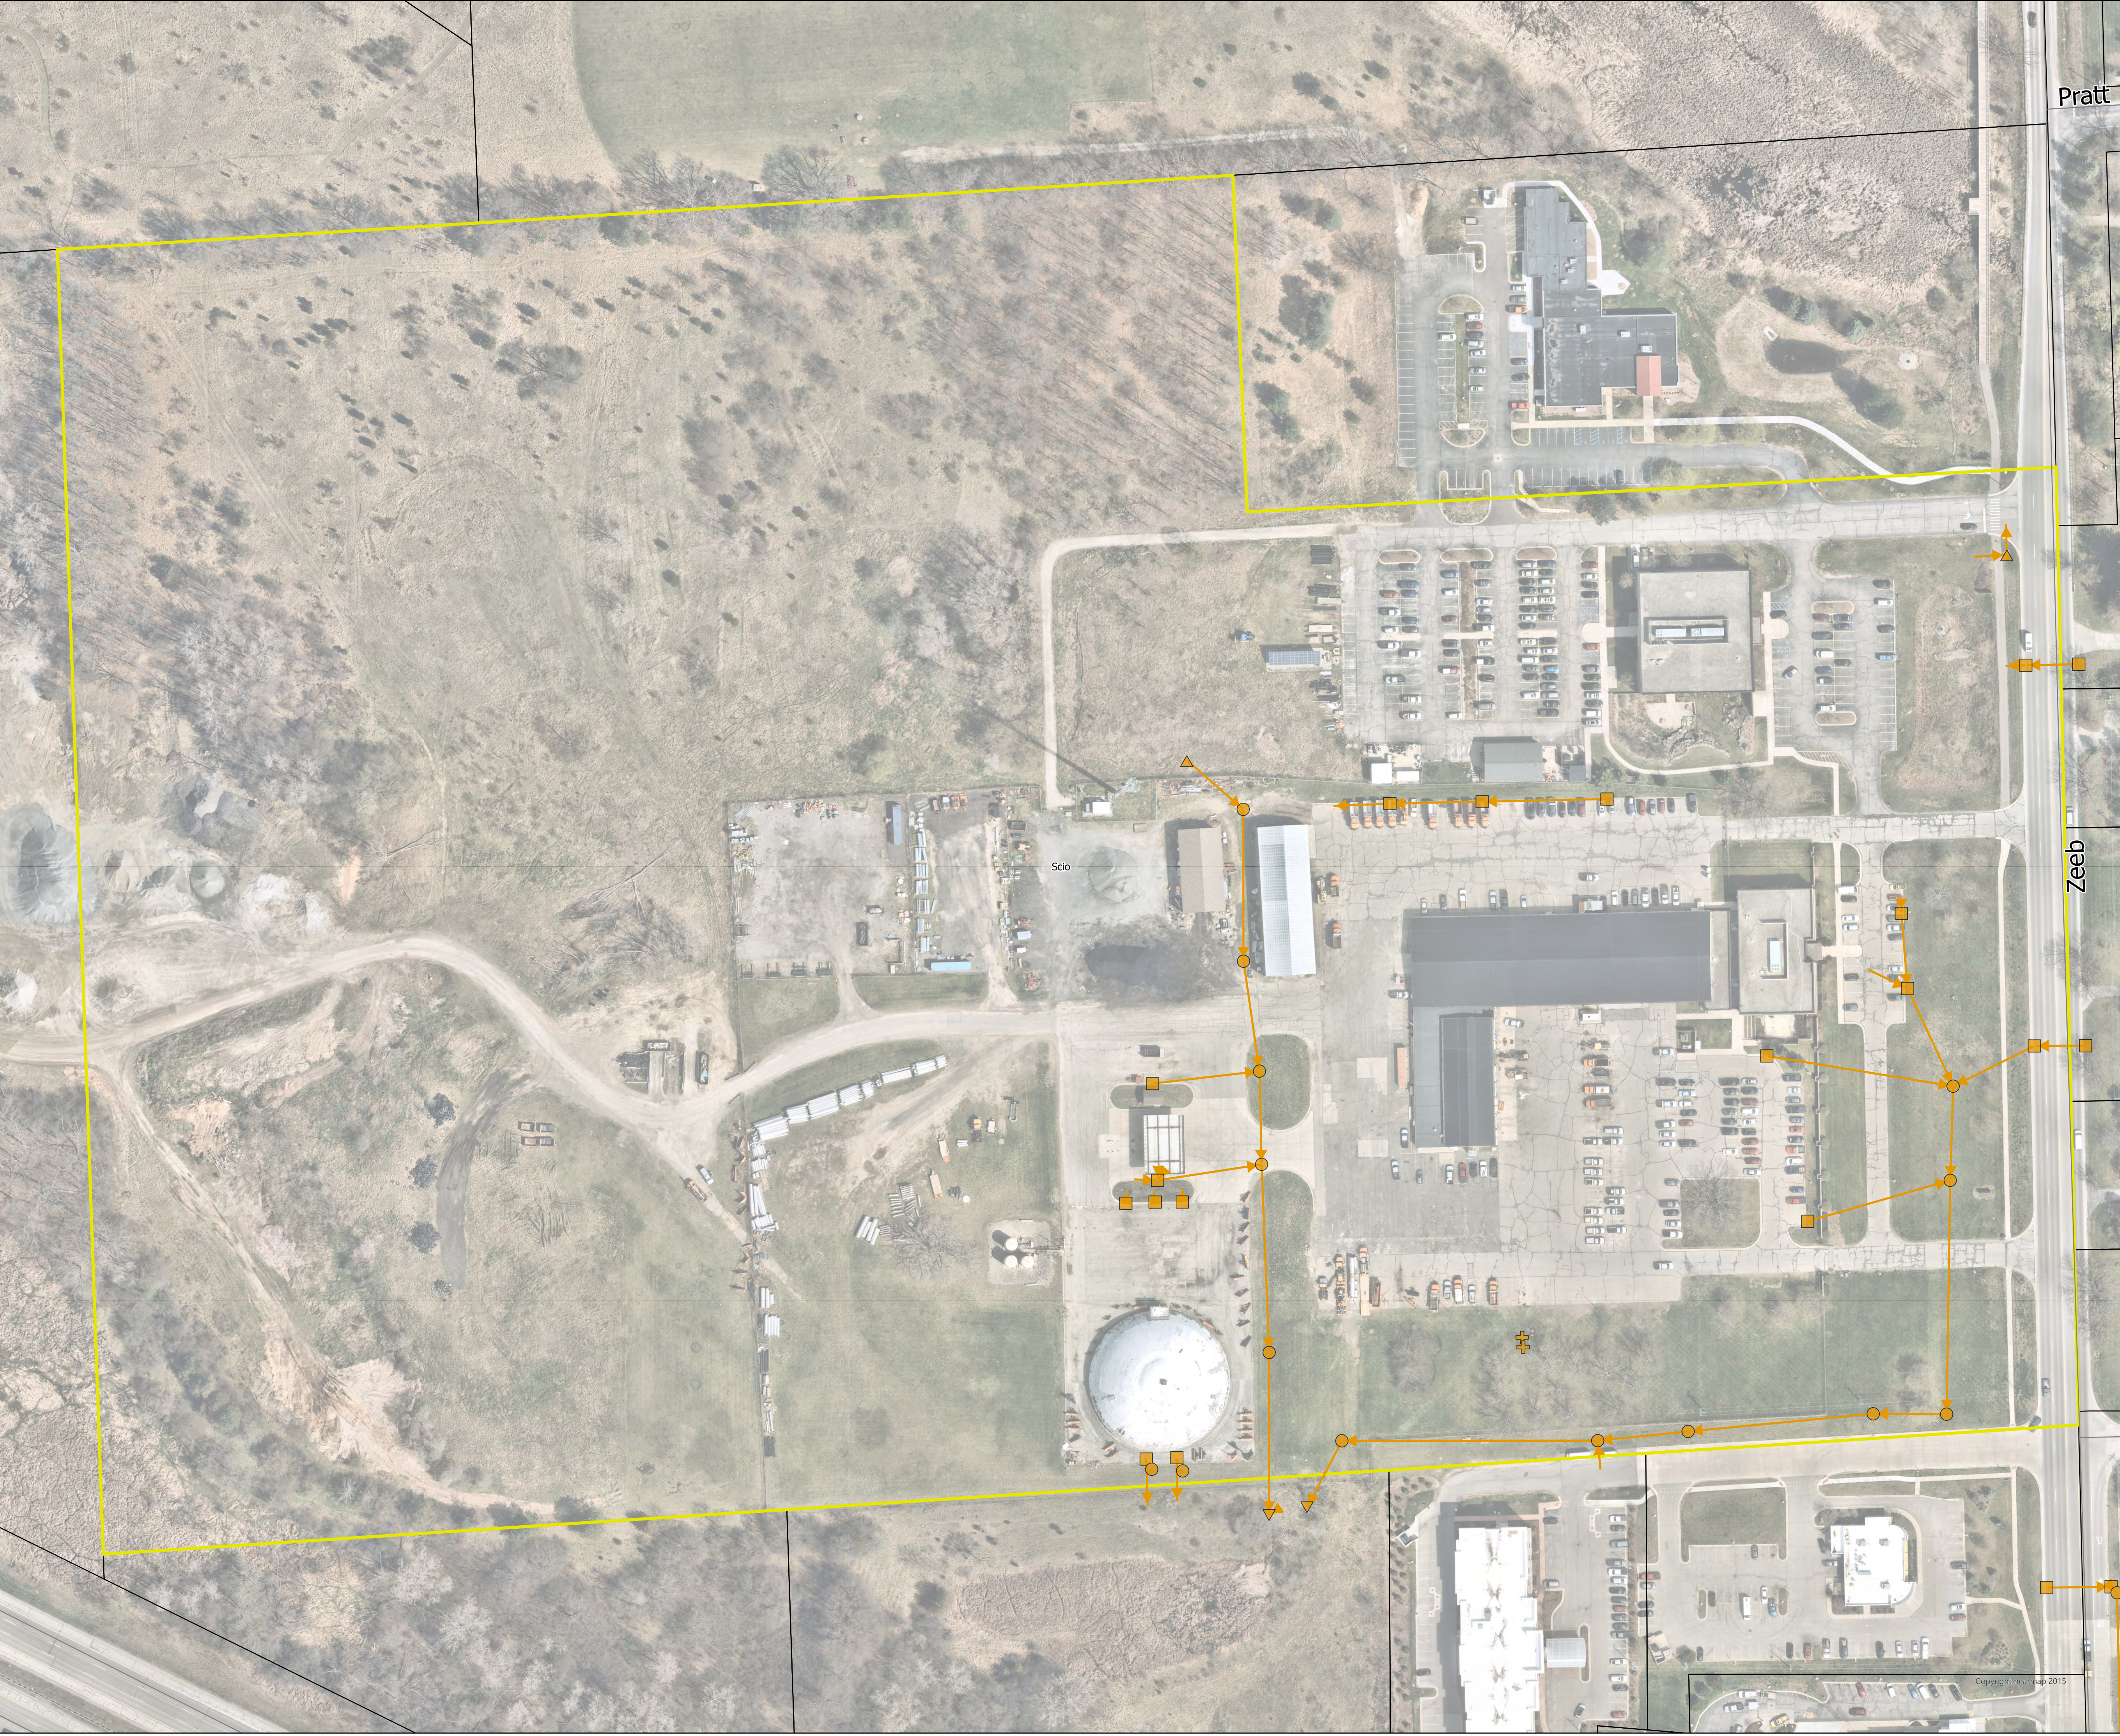
Zeeb Road
Service Center

- Legend
- Structures
- Catch Basin
 - Manhole
 - ▲ Inlet
 - ▼ Inlet End Section
 - ⊕ Other Special Chamber
 - Pipes

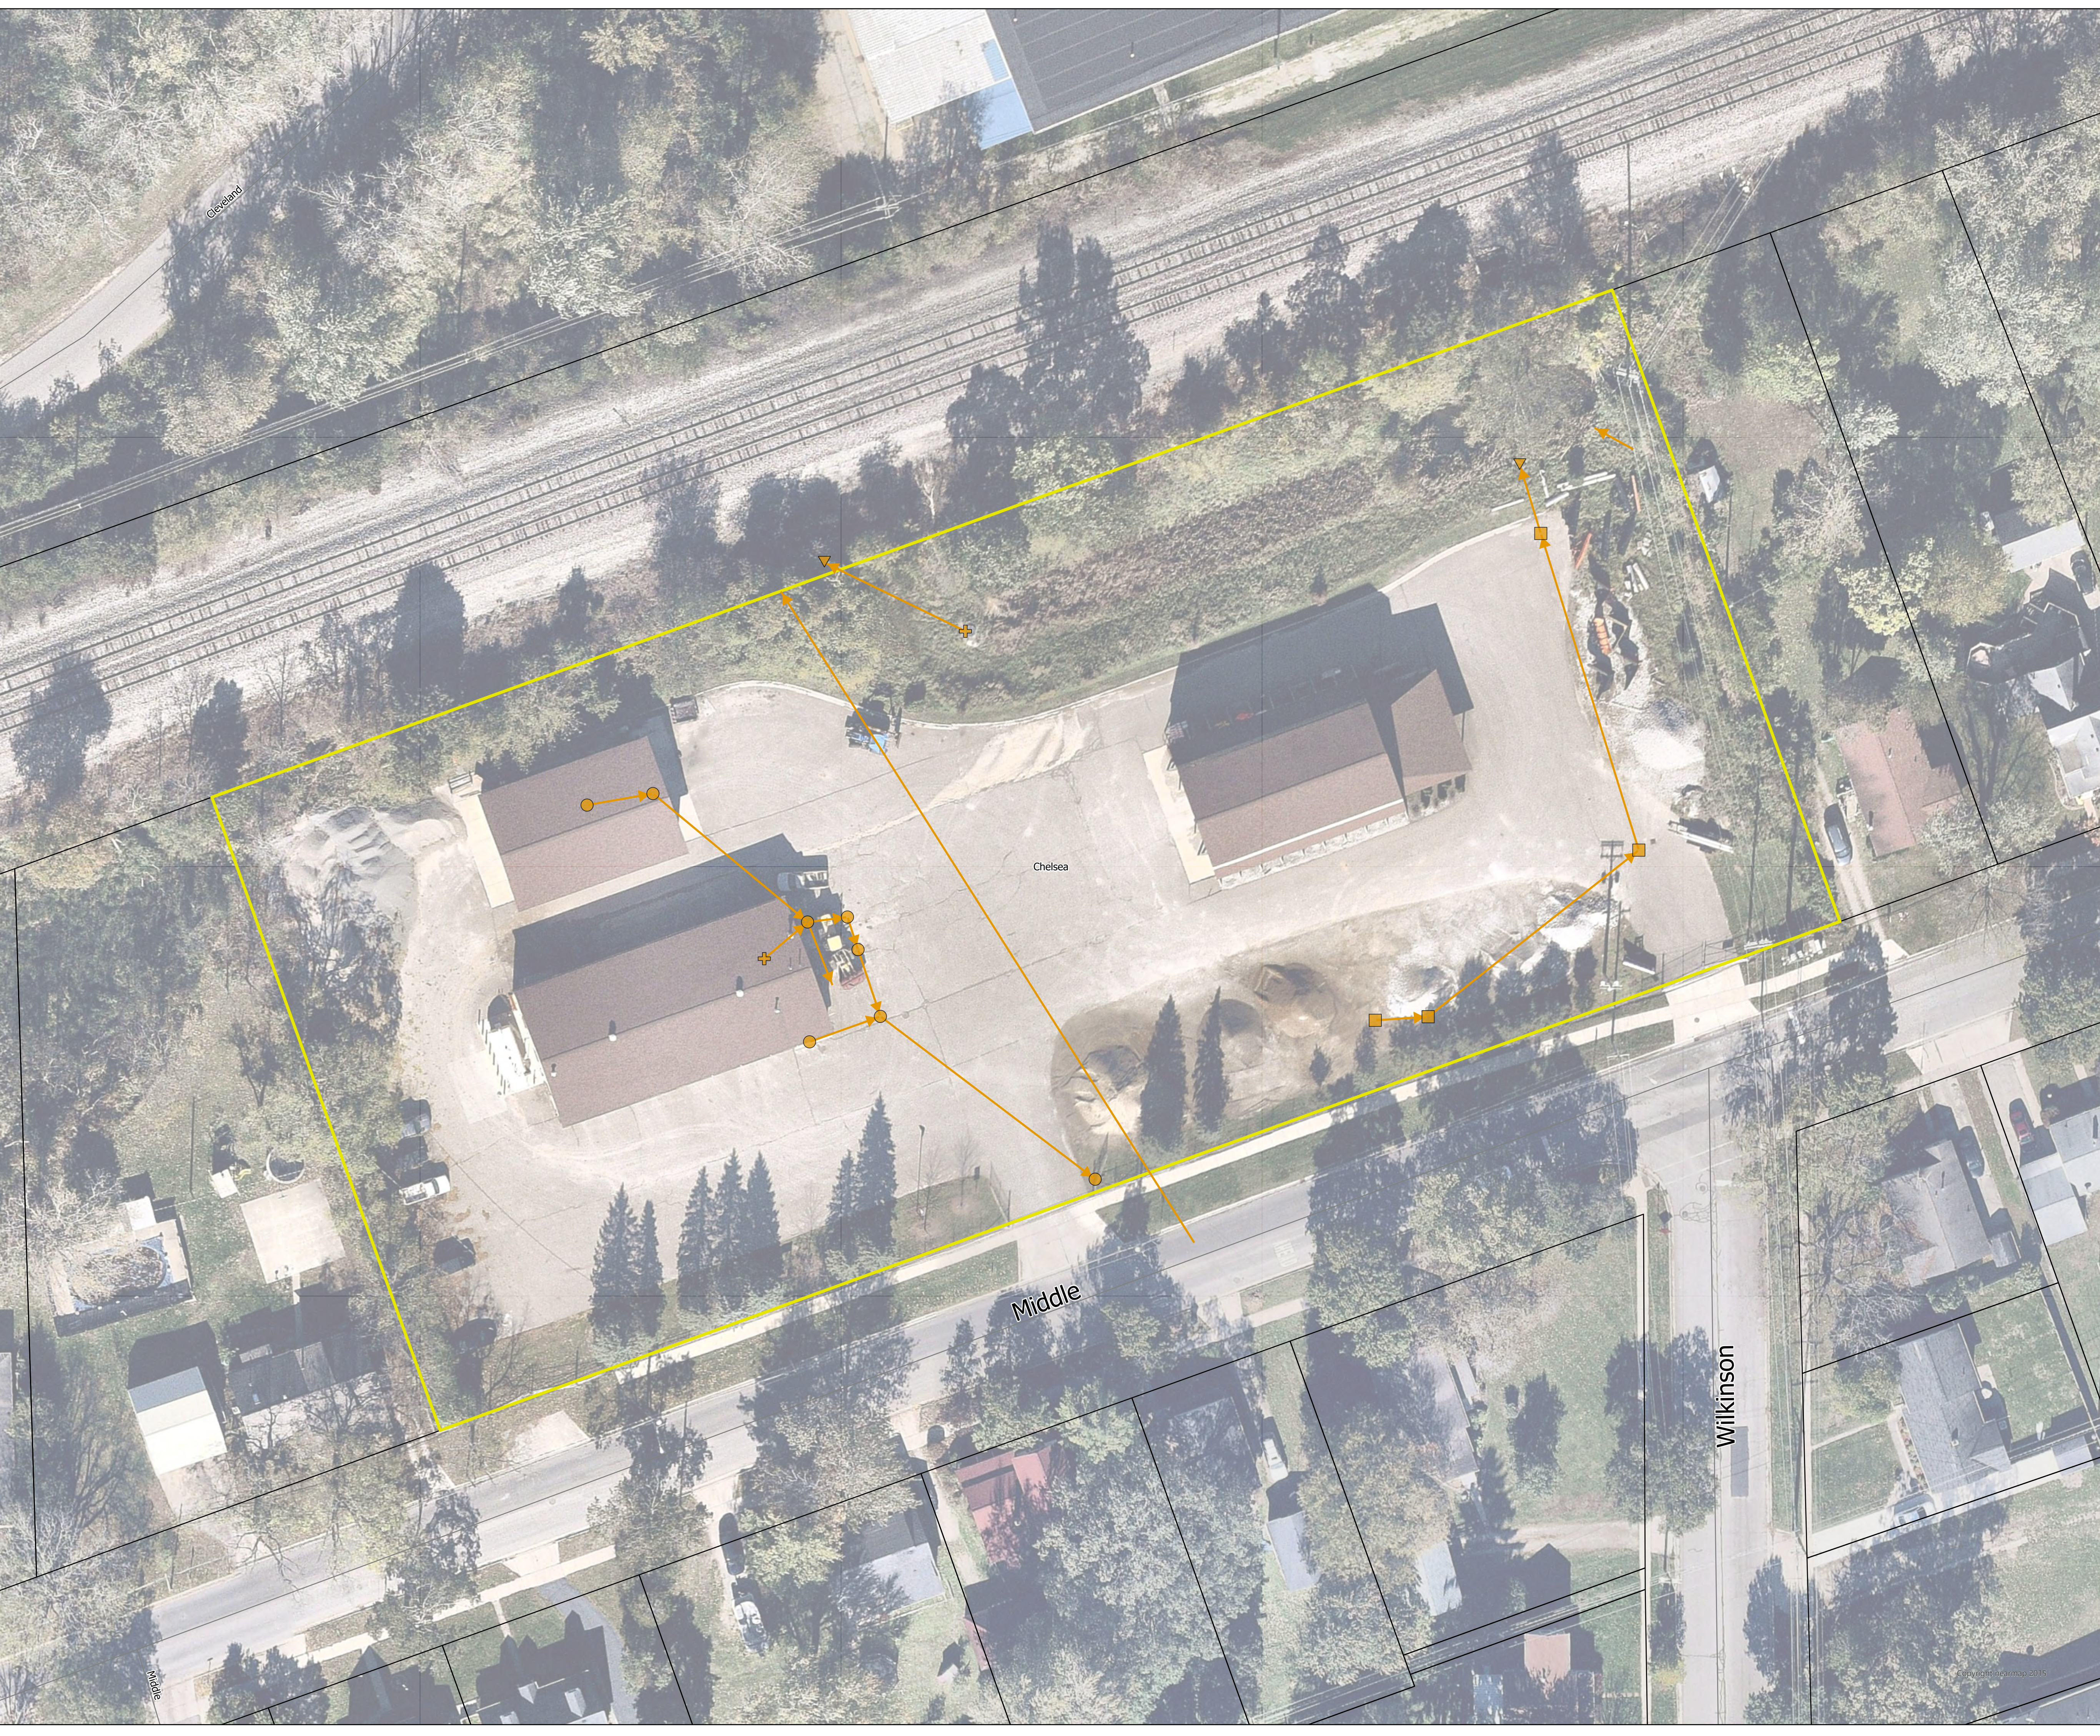
Chelsea
Service Center

- Legend
- Structures
- Catch Basin
 - Manhole
 - Inlet
 - Inlet End Section
 - Other Special Chamber
 - Pipes

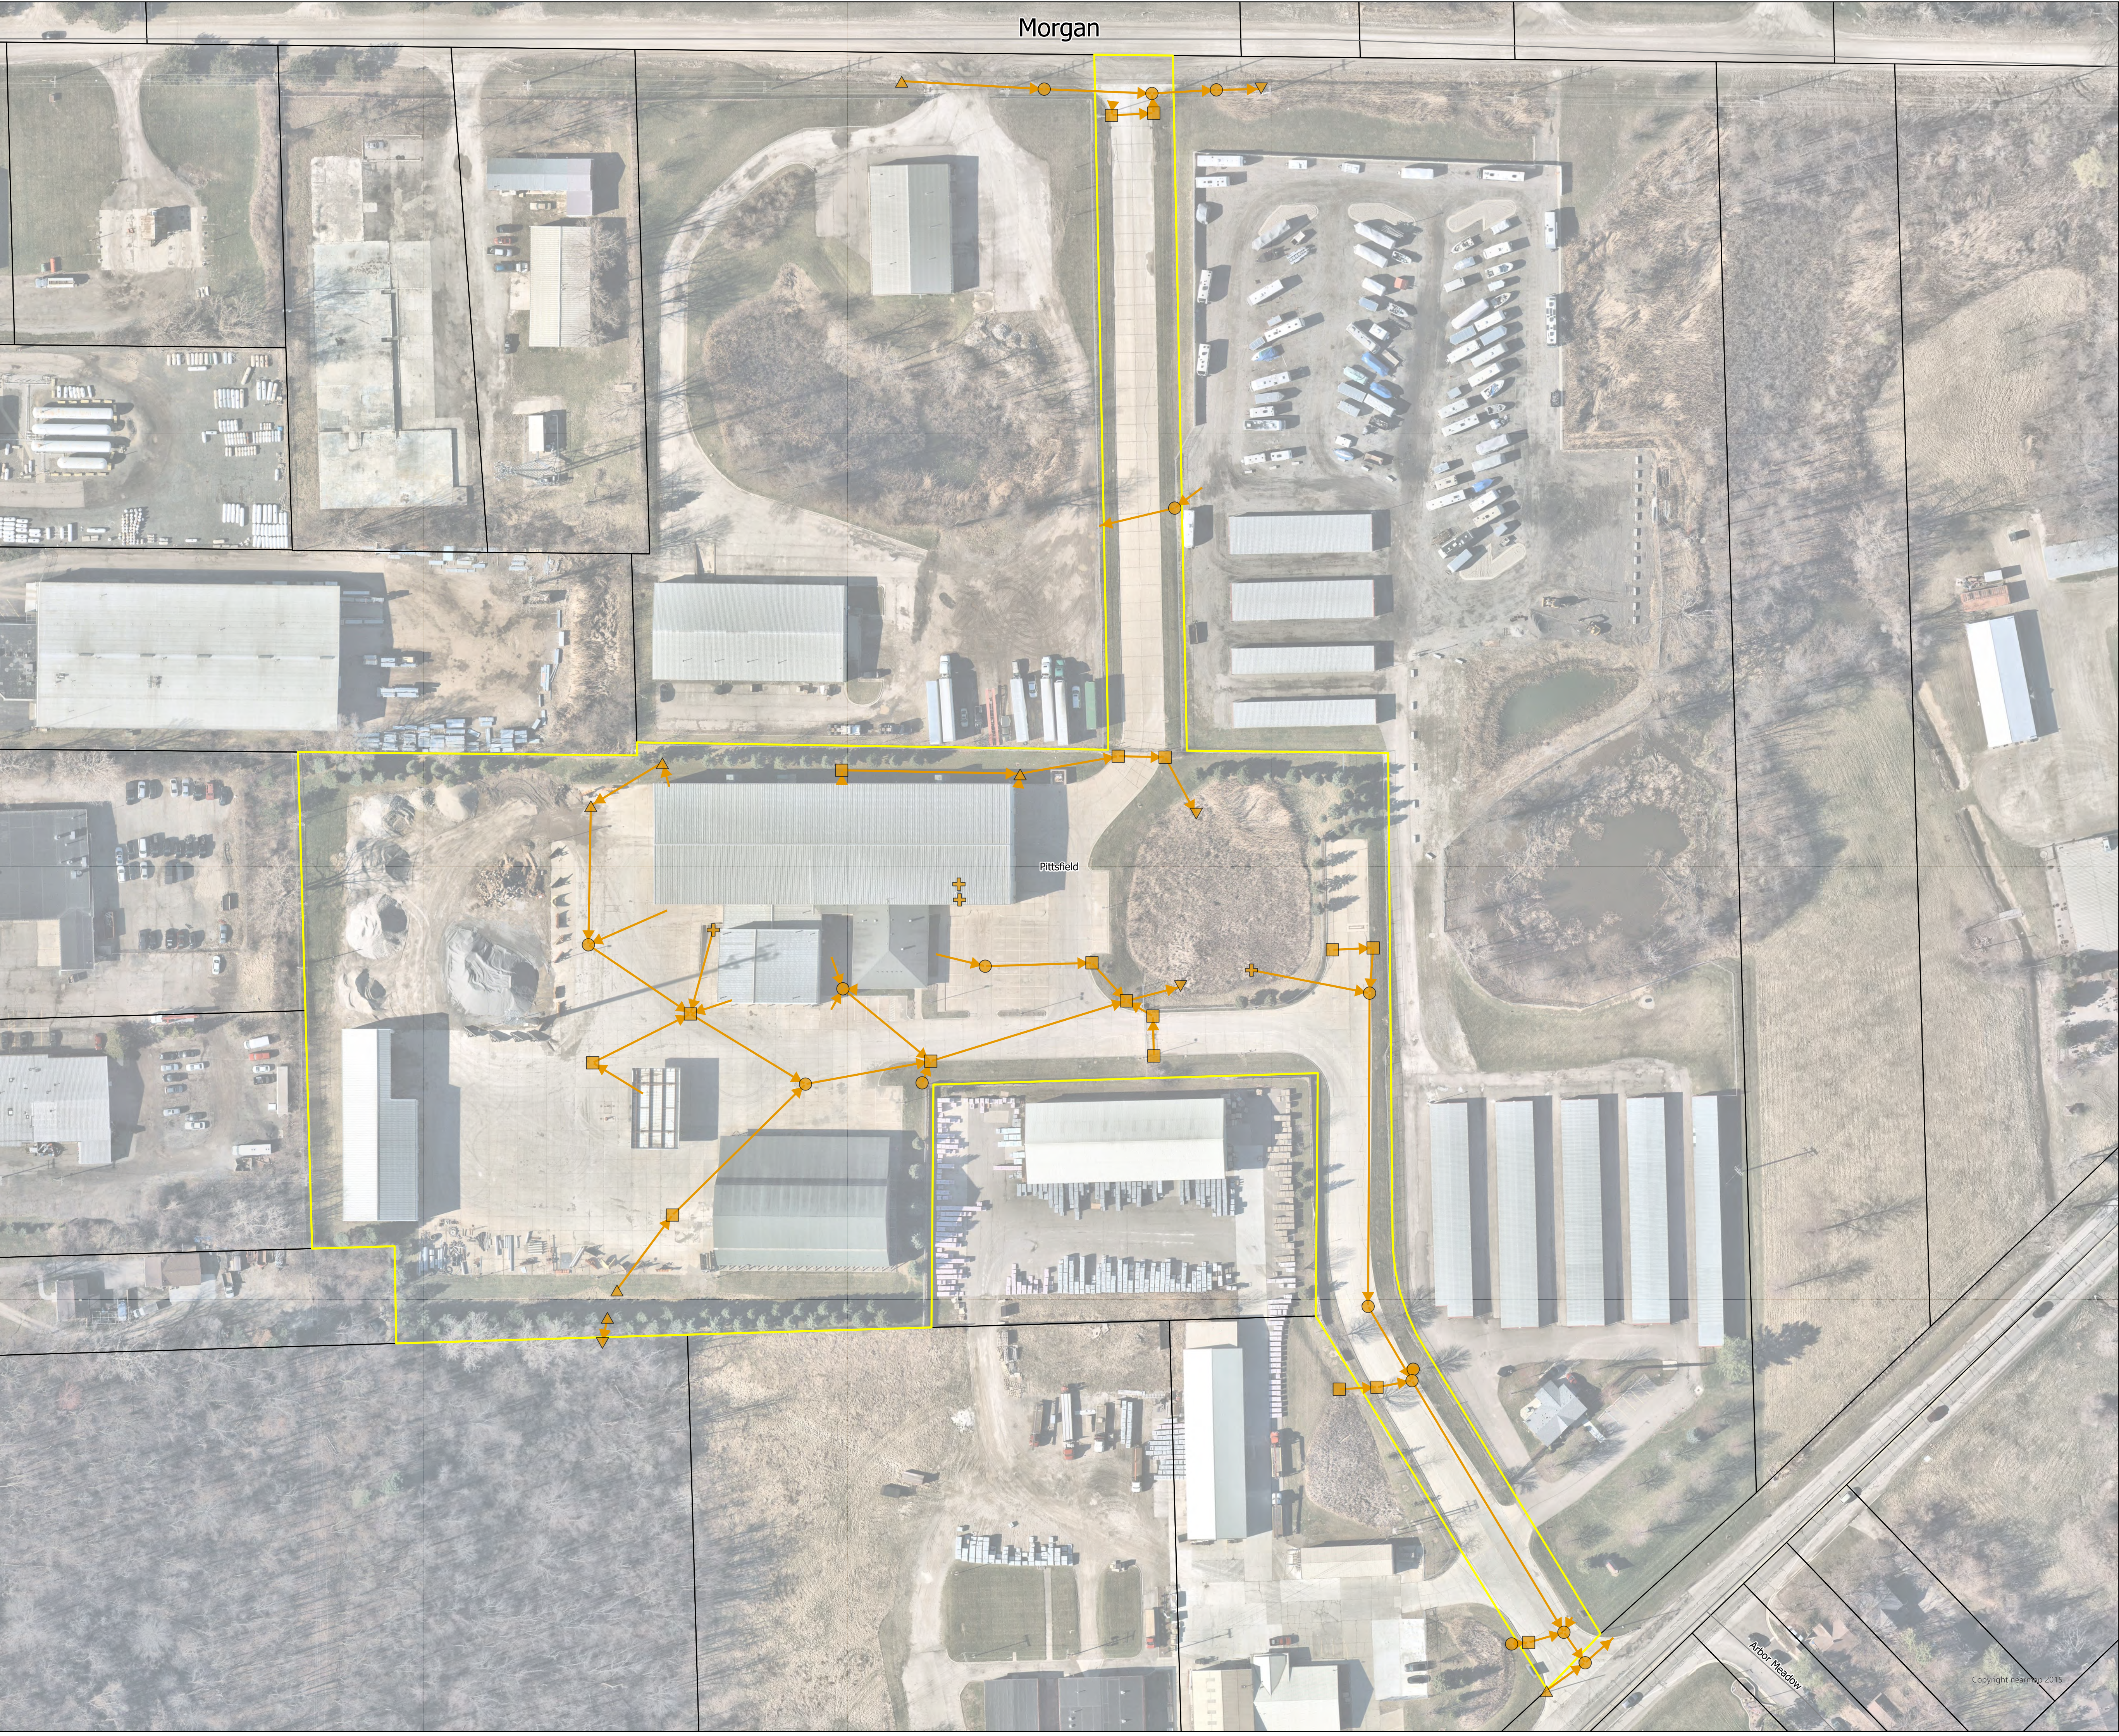
Michigan Ave. Service Center

Legend

Structures

- Catch Basin
- Manhole
- ▲ Inlet
- ▼ Inlet End Section
- ✚ Other Special Chamber
- Pipes

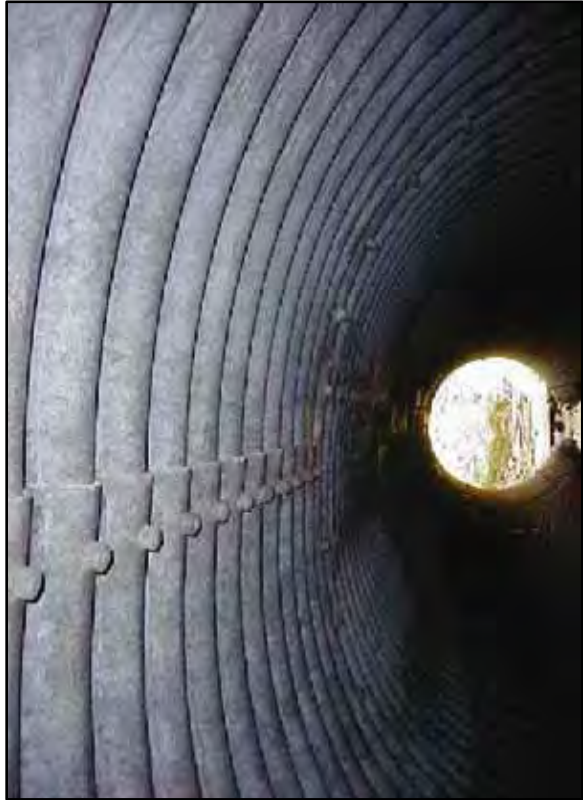
CMP JOINTS & SEAMS

CMP Joints & Seams	Pipe Joints or Seams	Multi-plate Joints or Seams	Condition
10	Straight line between sections.	Minor amounts of efflorescence or staining	Excellent
9	No settlement or misalignment. Tight with no defects apparent.	Light surface rust on bolts due to loss of galvanizing. Efflorescence staining.	Very Good
8	Minor misalignment at joints. Minor settlement. Distress to pipe material adjacent to joint.	Metal has cracking on each side of a bolt hole; Less than 3 in a seam section. Minor seam openings that are less than 1/8 inch. Potential for backfill infiltration. More than 2 missing bolts in a row. Rust scale around bolts.	Good
7	Misalignment of joints but no infiltration. Settlement. Dislocated end section. Extensive areas of shallow deterioration.	Evidence of backfill infiltration through seams.	Satisfactory
6	Joint open and allowing backfill to infiltrate. Significant cracking or buckling of pipe material. Joint offset less than 3 inches. End sections dislocated and about to drop off from main portion of the structure. Infiltration staining apparent.	Moderate cracking at bolt holes along a seam in one section. Backfill being lost through seam causing slight deflection. Less than 6 missing bolts in a row or 20% along the total seam.	Fair

5	Differential movement and separation of joints. Significant infiltration or exfiltration at joints. Joint offset less than 4 inches. Voids seen in fill through offset joints. End sections dropped off at inlet.	Major cracking of seam near crown. Infiltration of backfill causing major deflection. Partial cocked and cusped seams. 10% section loss to bolt heads along seams.	Poor
4	Significant openings. Dislocated joints at several locations exposing fill material with joint offsets greater than 4 inches. Infiltration or exfiltration causing misalignment of pipe and settlement or depressions in roadway. Large voids seen in fill through offset joints.	Longitudinal cocked and cusped seams. Metal has 3 inch crack on each side of the bolt hole run for the entire length of the culvert. Missing or tipping bolts.	Serious
3	Culvert not functioning due to alignment problems throughout. Large voids seen in fill through offset joints.	Seam cracked from bolt to bolt. Significant amounts of backfill infiltration.	Critical
